**EVALUATION OF STEEL H-PILES WITH LOCALIZED  
CORROSION AND REHABILITATION USING FRICTION-TYPE  
BOLTED STEEL PLATES**

A Dissertation

University of Houston

The research presented in this dissertation was funded by Texas Department of Transportation (TxDOT) on Project 0-6731 Repair Systems for Deteriorated Bridge Piles. The experimental funding was provided by TxDOT; and the license of numerical software was provided by University of Houston. Their generous supports are gratefully acknowledged.

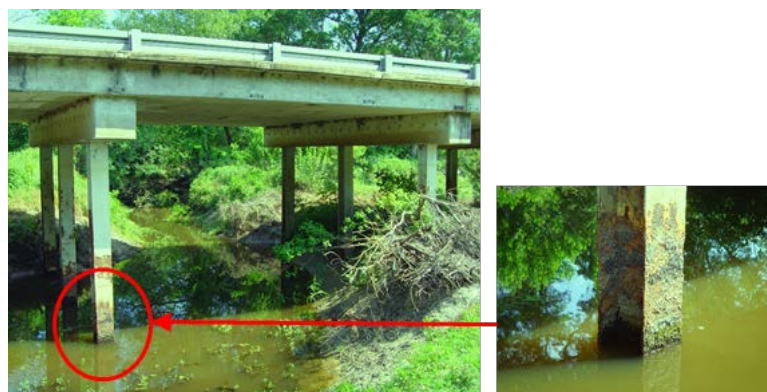
**Figure 1.1 Corroded piles from field view**

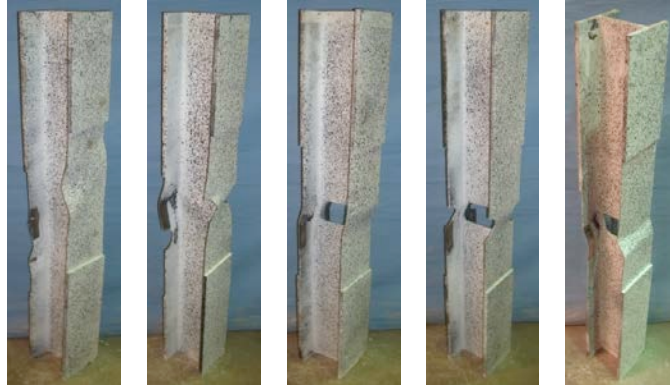
**Figure 2.5 Small-scale W-shaped members with flange/web thickness reduction**

Karagah et al. (2015) tested 13 small-scale, 32 in long W4×13 short steel columns with different degrees and patterns of sectional deterioration. The deterioration was achieved by machining the flange and web to reduce their thicknesses and flange width, as shown in Figure 2.5. The findings of the research indicated that reduction of the flange thickness resulted in a lower axial capacity than reduction of web thickness. The capacities of the columns were predicted using various design models and the dimensions of the reduced sections of the columns. The axial capacities that were predicted using the American Association of State highway and Transportation Officials (AASHTO) method were overly conservative (up to 56% lower than measured capacities) for severely corroded piles with total section loss greater than 50%. The predicted capacities using the direct strength method were also overly conservative (up to 55% less than measured capacities). The AISI's effective width method provided more accurate predictions compared to the other two methods, but still predicted 40% lower than experimental capacity for extremely corroded specimens. This illustrates the need to develop a method for more reliable prediction of axial members with localized corrosion.

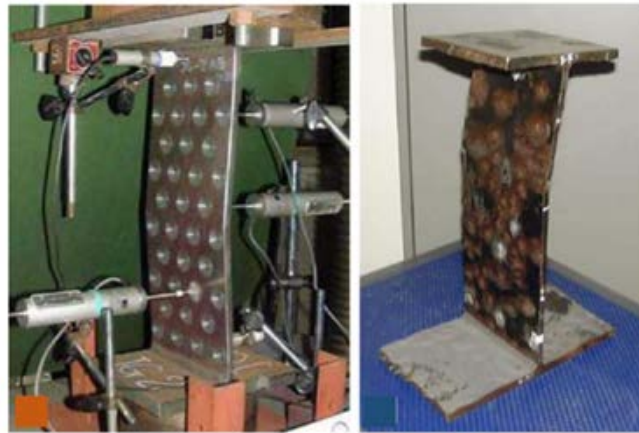
**Figure 2.7 Compression test on steel plate with pit corrosion**

Nakai et al. (2004) investigated the influence of pit corrosion on steel plate. Compression tests were conducted on plates with various distributions of pit corrosion. Figure 2.7(Nakai et al., 2004) shows the test setup. The pit corrosion was simulated by milling the thickness of plate at certain locations. Finite element analysis software MSC.Marc was used for an elasto-plastic analysis to simulate the effect of corrosion pit on compressive buckling behavior. The analysis results indicated that compressive buckling strength of pitted members was smaller than or equal to that with uniform thickness loss in terms of average thickness loss. Therefore, it is conservative to assume average thickness loss when predicting the remaining capacity of plates with pit corrosion.
